BOLT BERANEK AND NEWMAN INC
CONSULTING • DEVELOPMENT • RESEARCH

Report No. 1890

INTERFACE MESSAGE PROCESSORS FOR
THE ARPA COMPUTER NETWORK

QUARTERLY TECHNICAL REPORT NO. 3
1 July 1969 to 30 September 1969

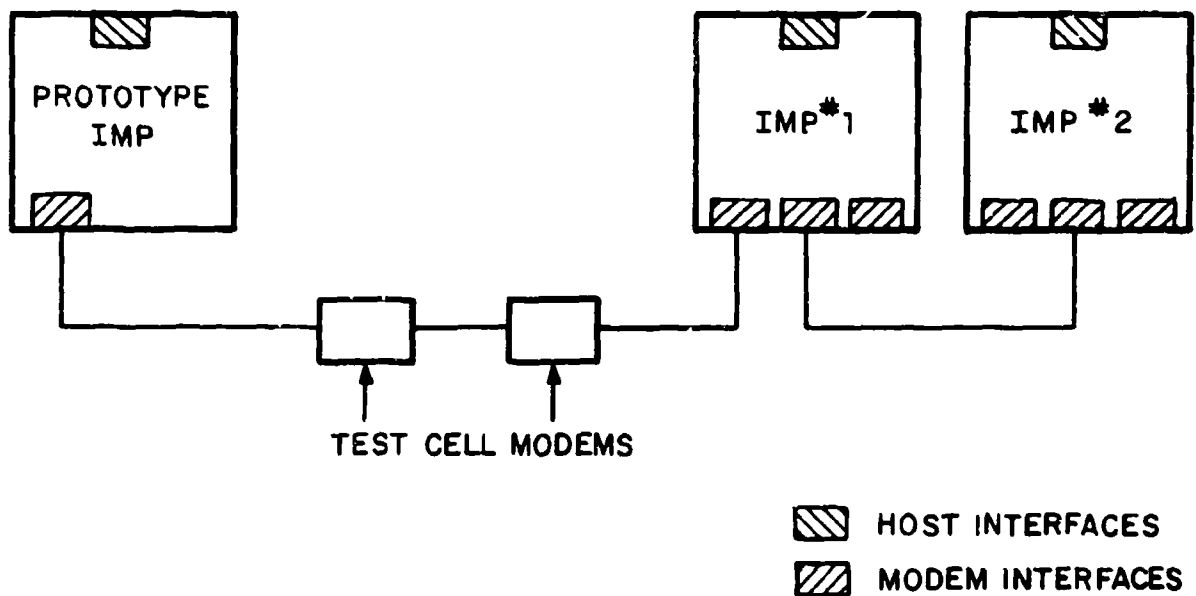
FIG. 1

interfaces, thereby removing the need for intervening modems. This modification allowed for the construction of a three node pseudo-network as shown in Figure 1 below:

This configuration provides a reasonably sophisticated setting for hardware testing and also allows for debugging of configuration dependent features (e.g., routing) of the operational program. An equivalent configuration was constructed using IMP No. 3 to replace IMP No. 1 after the latter had been shipped to UCLA.

A small temporary hardware patch to the Modem interfaces in IMPs 1 and 2 made possible the direct connection of these

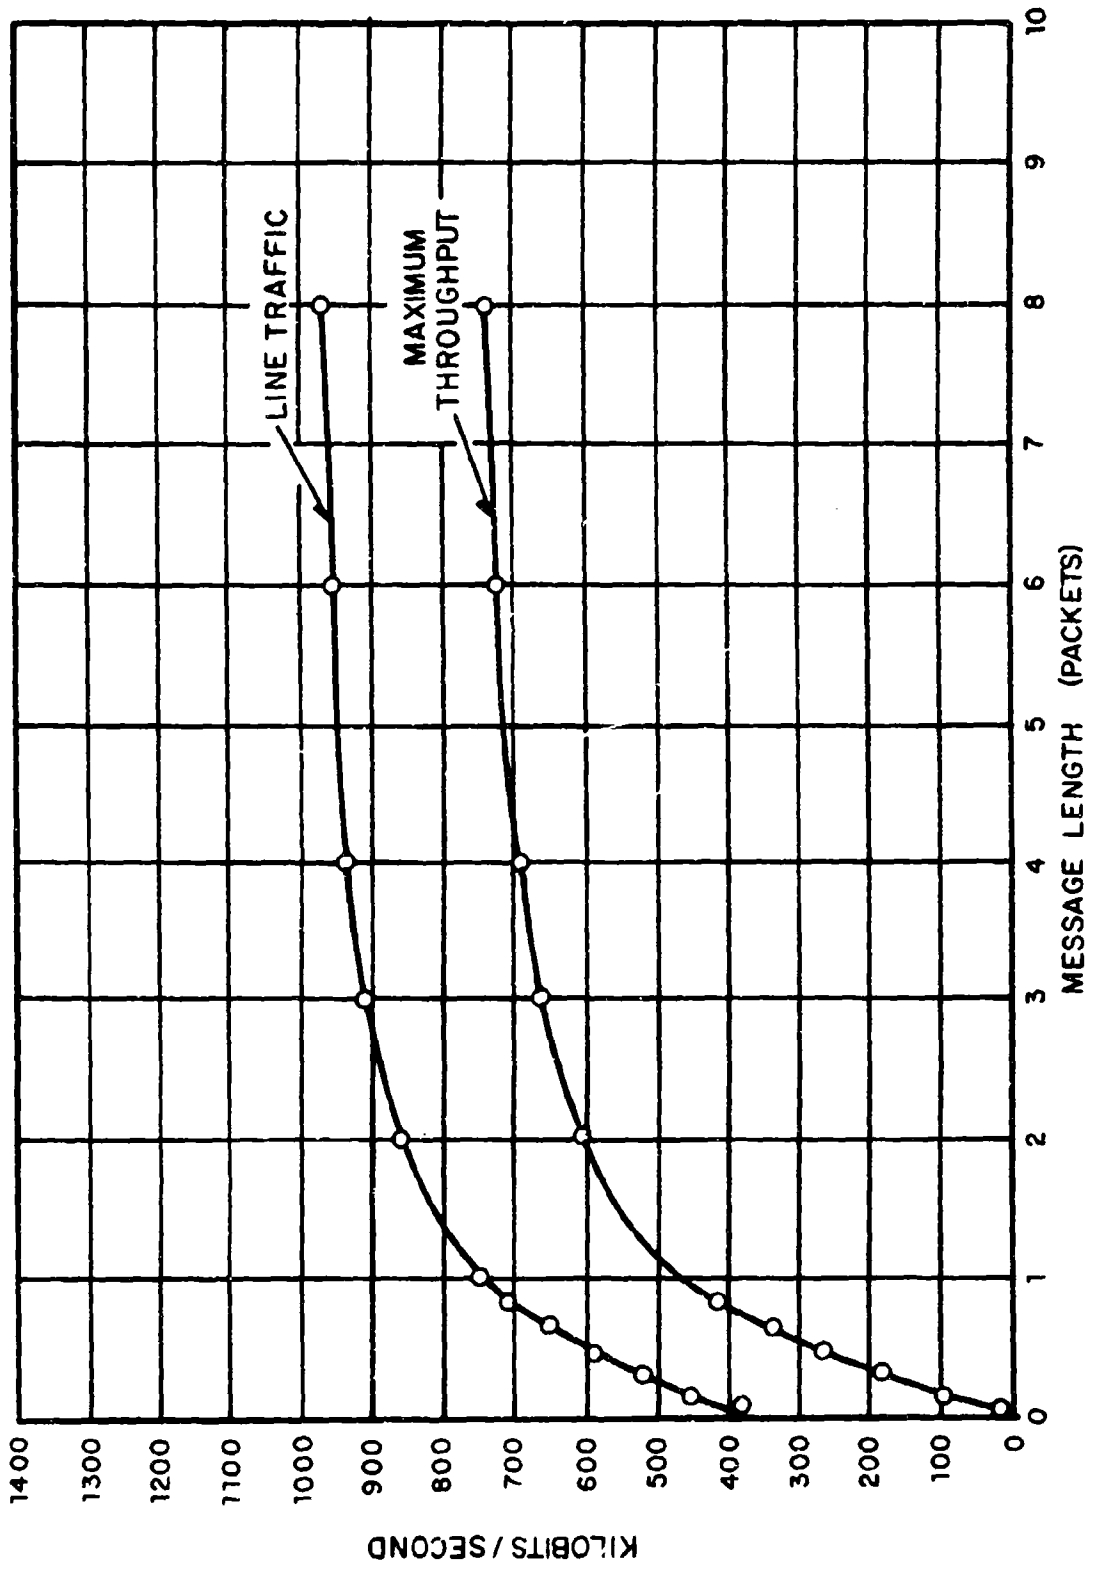
FIG. 2

The maximum IMP throughput of approximately 700,000 bits/second is achieved with large (8 packet) messages on nineteen effective channels. A curve of maximum throughput as a function of message length is shown in Figure 2. The difference between the throughput curve and the line traffic curve represents overhead.

We adopt the IMP throughput in bits/second as a measure of IMP performance. The throughput is the maximum number of

Host data bits that may traverse an IMP each second. The actual number of bits entering the IMP each second is somewhat larger than the throughput because of such message overhead as headers, RFNMs and acknowledgements. Each packet on the phone lines contains seventeen characters of overhead, thirteen of which are removed before the packet enters an IMP.
